## Tradeline Publications: Uncovering Weaknesses of Biocontainment Facilities

Orinda, California

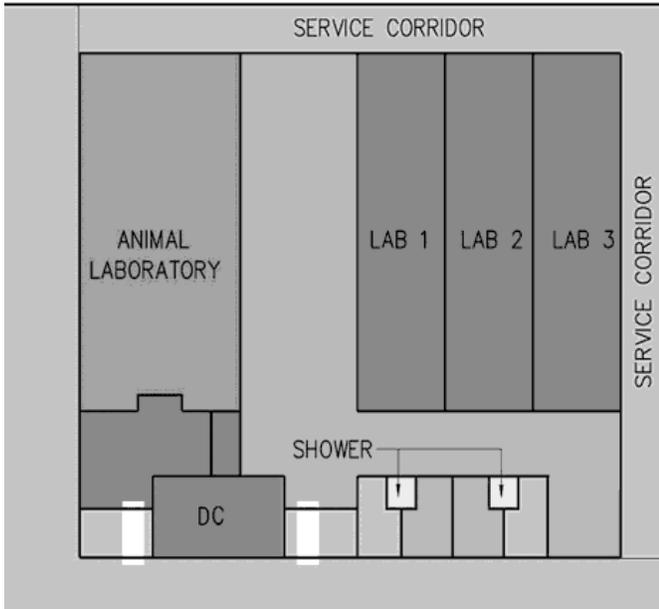
**Figure 1**

BSL-3

PRESSURE ZONE

- 120 Pa
- 90 Pa
- 75 Pa
- 60 Pa
- 30 Pa
- = 0 Pa

Pressure differentials should ensure that a reversal of pressures cannot occur. The areas of highest risk, such as animal laboratories, should be at the lowest possible pressure to prevent pathogens from escaping into surrounding areas of lower risk. Pressure in the animal laboratory is at -120 pascals. One hundred pascals is equal to 0.4 inches of water. (Image courtesy of Tony Della-Porta.)

The areas of highest risk, such as animal laboratories, should be at the lowest possible pressure to prevent pathogens from escaping into surrounding areas of lower risk. Della-Porta is currently providing consulting services to a BSL-3 lab in Thailand that is handling the avian flu. Pressure in the animal laboratory is at -120 pascals, while the pressure in the labs is at -90 pascals, the decontamination chamber is at -75, the showers are at -30, and the surrounding service corridor is at 0 pascals. Della-Porta explains that 100 pascals is equal to 0.4 inches of water.

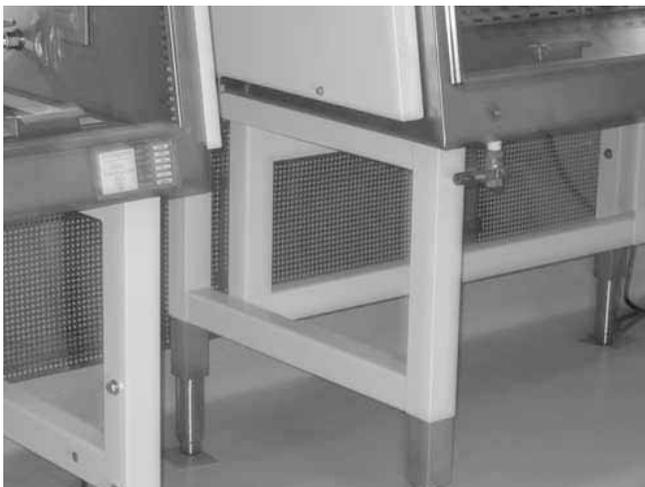
**Figure 2**

HEPA filters in biocontainment facilities are often incorrectly mounted beneath biological safety cabinets. In this instance, air cannot reach the filter in a proper manner. (Photo courtesy of Tony Della-Porta.)

Problems are also common with HEPA filter canisters, which are difficult to decontaminate, and it is difficult to scan test the filters. The location of the canisters is important, as well. They should not be located at floor level and they should not be close to an animal area where they can become contaminated.

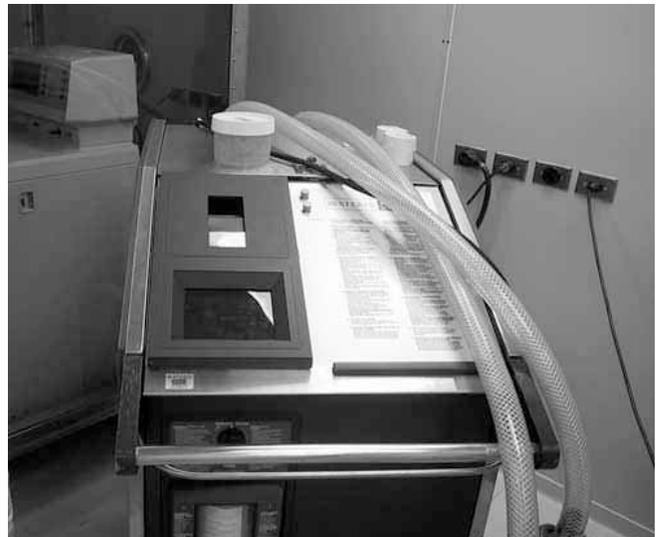
**Figure 3**

The SARS laboratory infection in Taiwan occurred because the person did not use a vaporized hydrogen peroxide generator like this one to clean up a spill. Instead, he used 70 percent alcohol and put his head in a BSL-3 biological safety cabinet without using a respirator. This room is not airtight because ordinary power points are mounted on the wall. (Photo courtesy of Tony Della-Porta.)

Power, communication, and gas services can be surface-mounted in moduline ducts. Ordinary power points and electrical fittings should not be mounted in walls because they will leak. Instead, special airtight plugs are necessary, unless a moduline fitting is used. Rubber gaskets for doors and pass boxes must be mounted correctly and be airtight when the door is sealed.

The 2003 SARS laboratory infection in Taiwan stemmed from a lack of management controls on the operation of the laboratory and training of staff. In this case, a principal investigator in a BSL-4 lab used 70 percent ethanol to decontaminate a spill in an isolator chamber. He opened the Class III biological safety cabinet without wearing a respirator and contracted the SARS virus.
